Driver Assist System (DAS) Technology to Support Bus-on-Shoulder (BOS) Operations

JUNE 2019

FTA Report No. 0135
Federal Transit Administration

PREPARED BY
Minnesota Valley Transit Authority

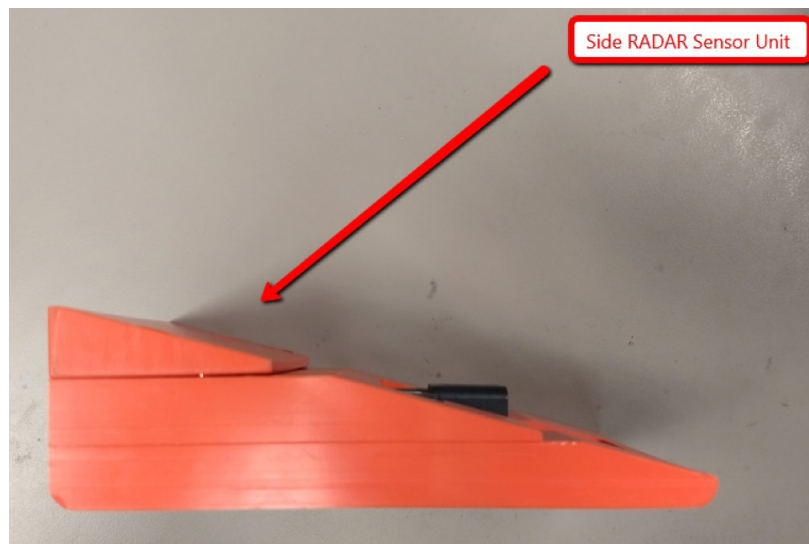
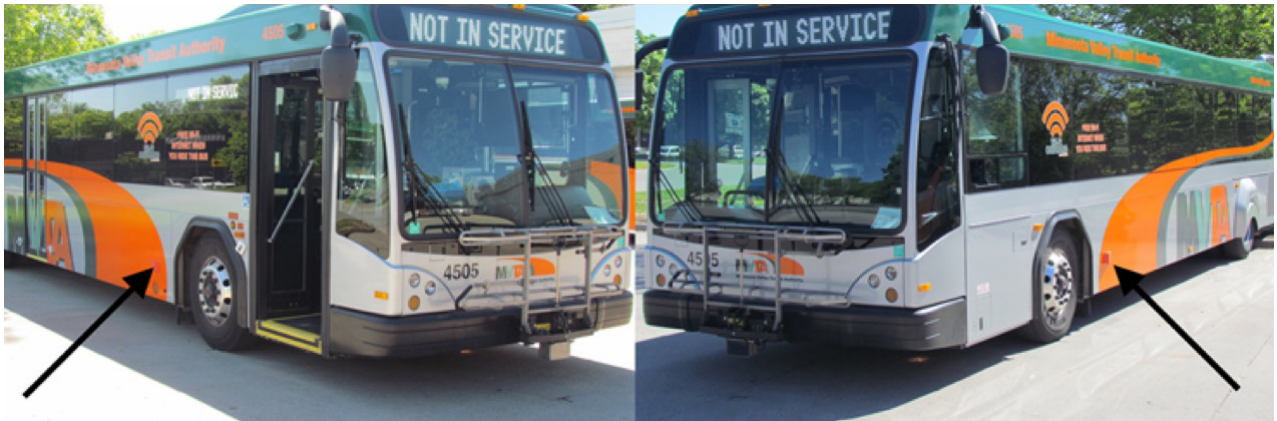
Figure 2-4

Lidar side collision awareness sensors were replaced by side radar sensors. With the GenI DAS, lidar was used for both forward and side collision awareness sensing. In practice, the side-looking lidar sensors were susceptible to damage. Recently introduced side-looking radar sensors have a much lower profile and are less susceptible to damage. As such, radar technology replaced lidar technology for side-looking collision awareness sensors.

*Side-Looking Radar
Component*

Side-Looking Radar Installed

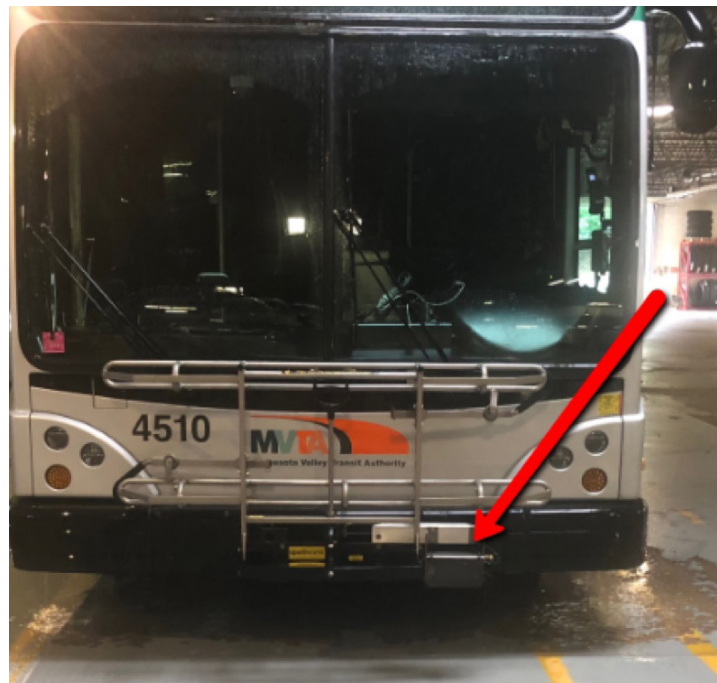
Front Lidar Sensor

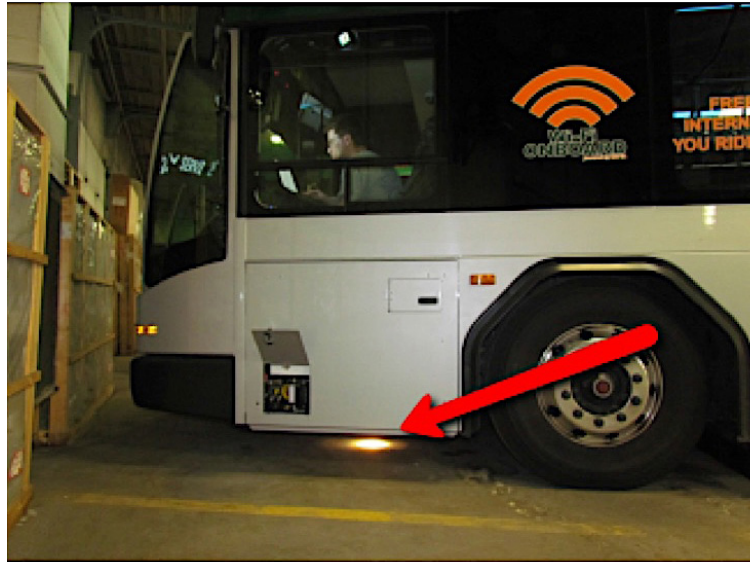
2D Sensor Light

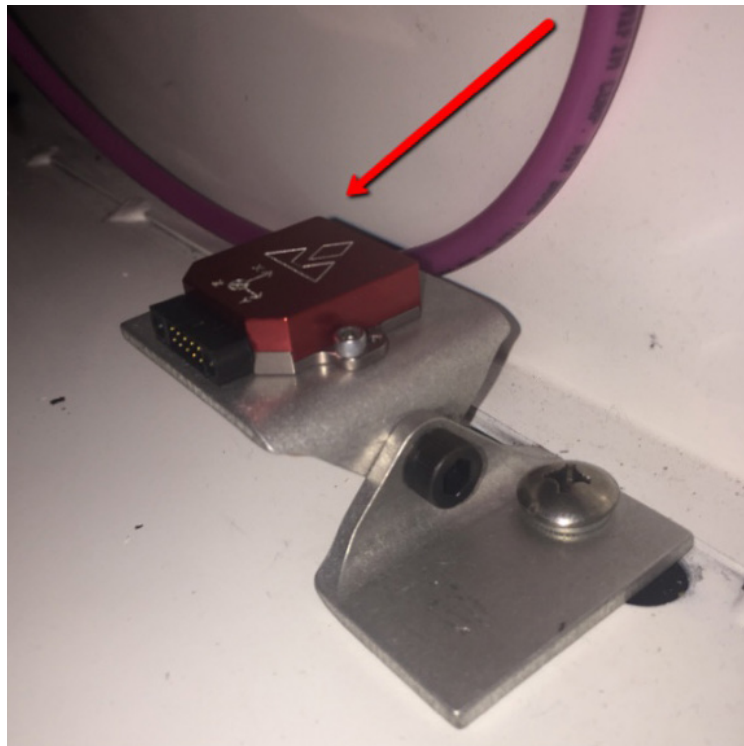
The Inertial Measurement Unit (IMU), which is also used for GPS augmentation, measures accelerations and rotation rates of the bus in all three directions.

*Inertial
Measurement
Unit*

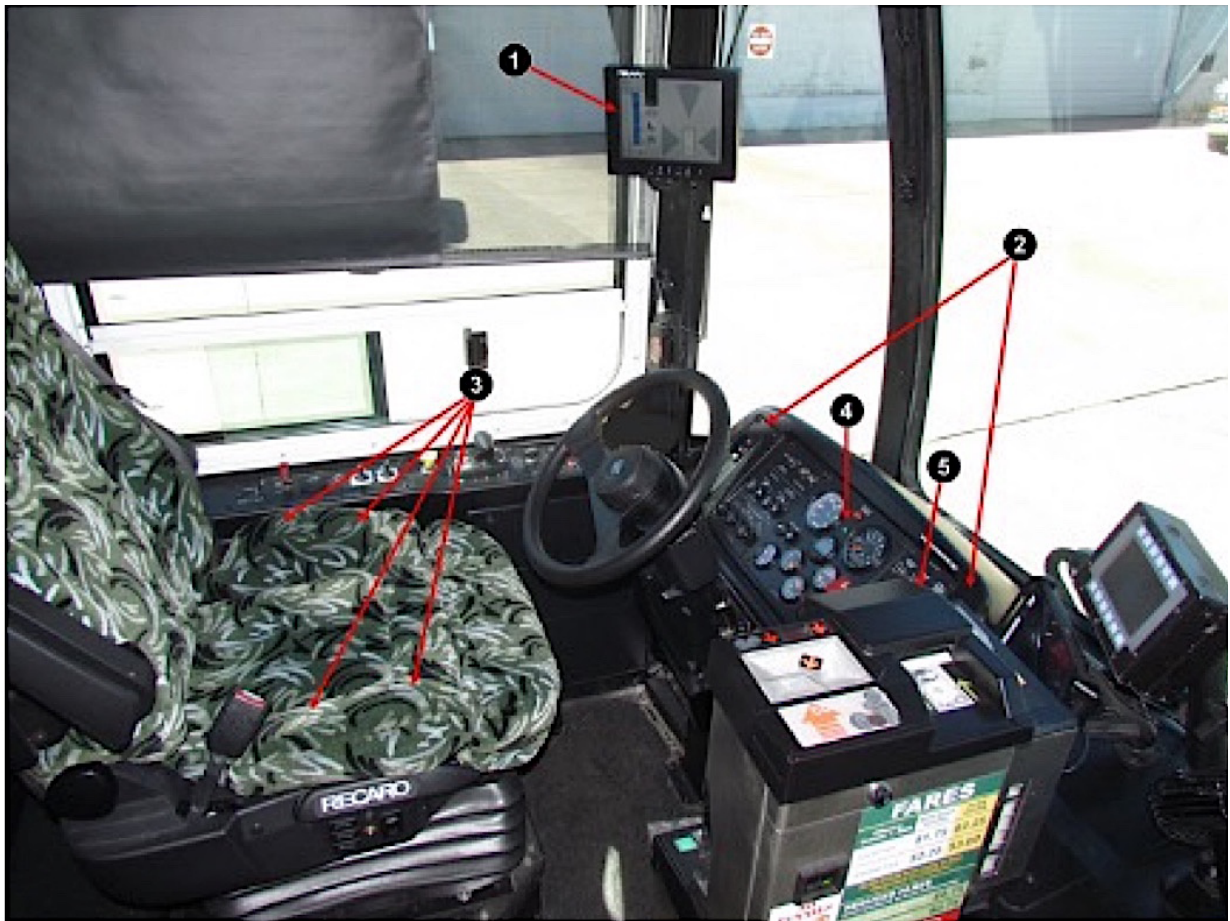
The locations of these components and feedback mechanisms within the driver area are shown in Figure 2-8 and discussed in the following sections.

1. Driver User Interface Screen (touch screen)
2. Lane Departure Warning LED (one on each side of dash)
3. Lane Departure Warning Tactile Seat
4. Forward Collision Awareness LED
5. DAS Power Button (green button, not in view)

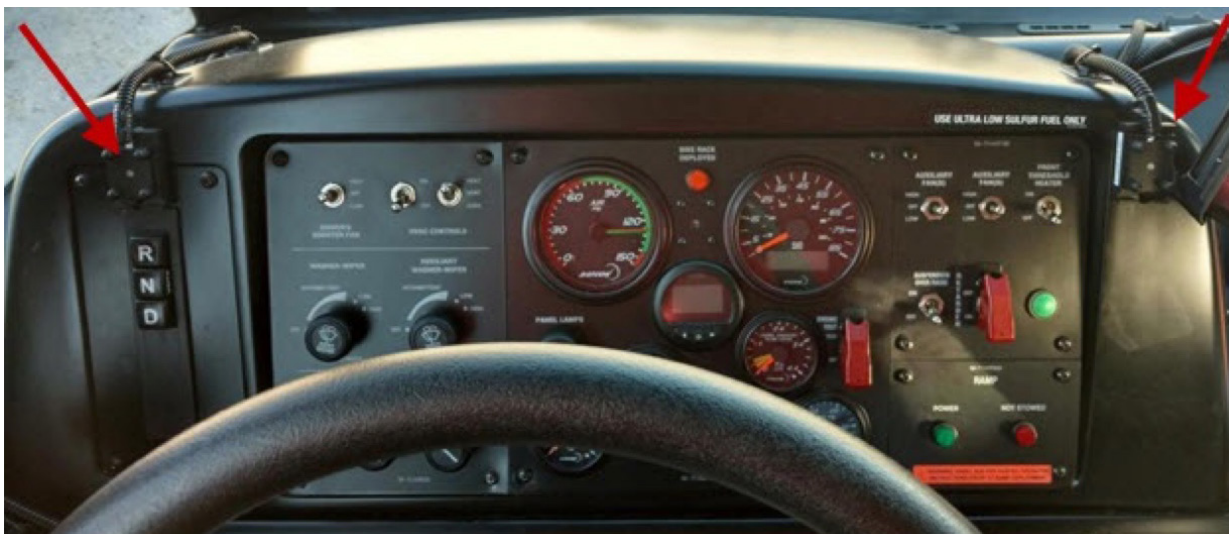
Figure 2-10

Lane-departure warnings come in stages. When the vehicle-trajectory estimator determines that the likelihood of a lane departure is sufficiently high, a lane departure warning is issued to the driver through the appropriate LED. Should the driver continue towards the lane boundary, a seat-based warning is activated; the side of the seat corresponding to the side of the lane departure vibrates, warning the driver. This multistage approach captures the driver's attention, but if he/she responds in a timely fashion, annoyance is limited.

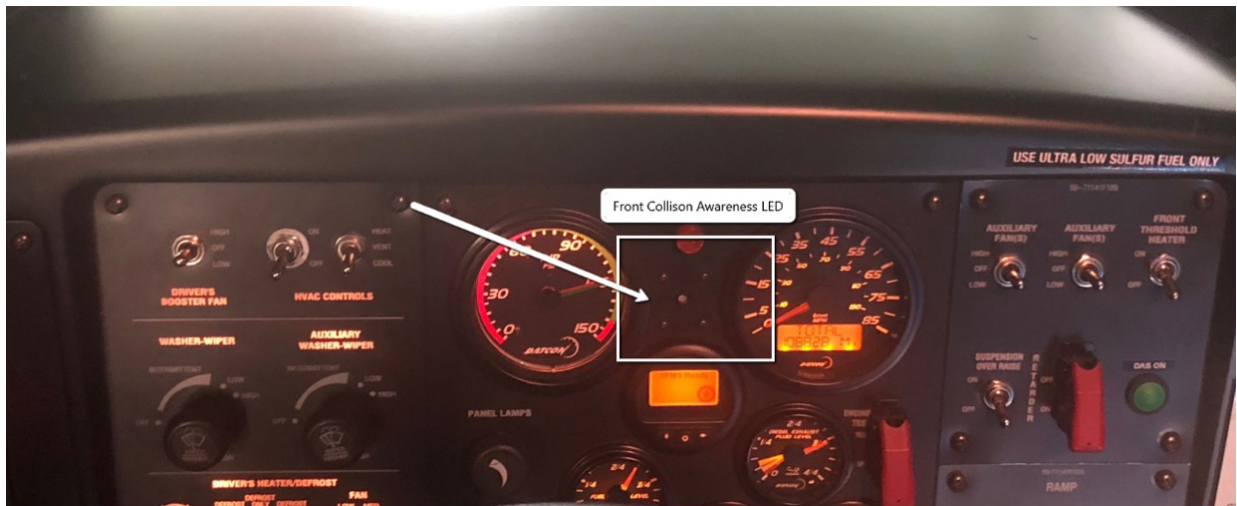
Figure 2-11

The forward collision awareness feature is used to warn the operator of an impending forward collision event. It uses an LED indicator mounted on the instrument panel directly in front of the bus driver to indicate a possible collision of the front of the bus with another object if the feedback mode is enabled on the driver user interface and an obstacle is present in front of the bus. Further, the LED uses a combination of frequency and intensity to cue a driver as to the level of threat posed by the obstacle ahead.

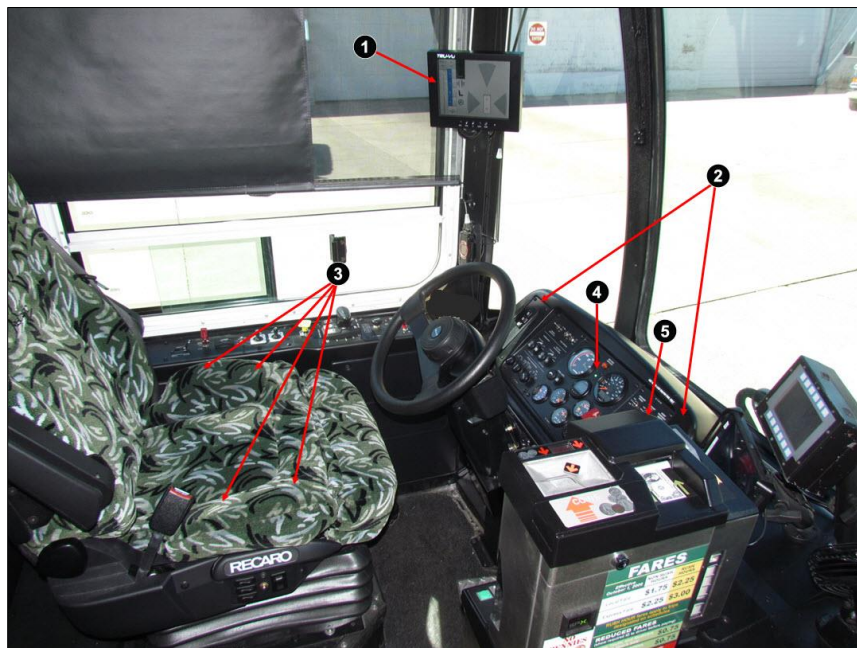
The Gen2 DAS has two modes of feedback to the bus operator—visual and tactile. Visual feedback is provided through a combination of light emitting diodes (LEDs) located on the bus operator’s dashboard and a liquid crystal display (LCD) touch screen on the bus’s A-pillar. Tactile feedback is provided by vibrators located inside the operator’s seat cushion. Another difference between the Gen2 and Gen I DAS involves the use of radar. Whereas lidar was used in the Gen I DAS to provide both front and side collision sensing, the Gen2 DAS uses lidar for front collision sensing and radar for side collision sensing. A photo of the interior of the bus operator’s area with the DAS components is shown in Figure I-2.

- 1 LCD Touch Screen
- 2 Lane Departure LED (one on each side of dash)
- 3 Active Seat
- 4 Forward Collision Awareness LED
- 5 DAS Power Button (green button, not in view)

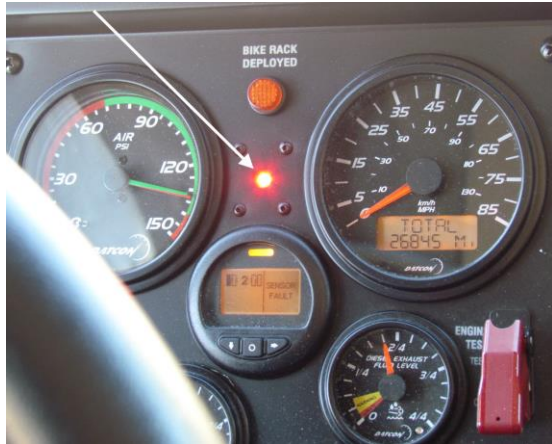
stages. Stage 1 occurs when a vehicle or obstacle is detected in front of the bus and the time to collision is greater than three seconds. The LED light glows steady amber, and the red warning icon appears on the LCD display. Stage 2 occurs when a vehicle or obstacle is detected in front of the bus and the time to collision is less than three seconds. The LED light flashes red, and the blinking rate is proportional to the distance from the obstacle. The LCD display continues to display the red warning icon.

Figure I-3 Forward Collision LED

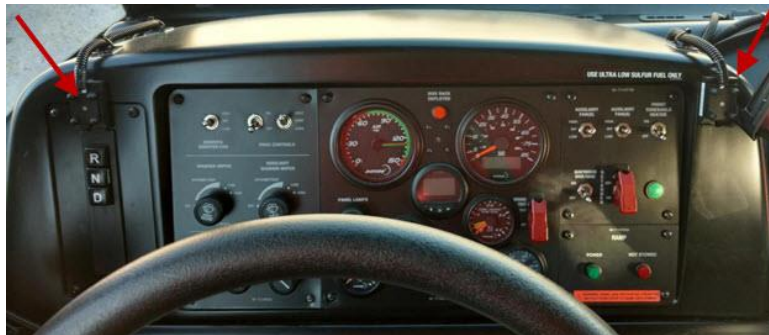
Lane departure warning is provided both graphically and tactically. Graphically it is provided by means of LED warning lights located on the left and right sides of the dashboard (Figure I-5) and an icon of a bus with a red dashed line on the LCD display (Figure I-6). Tactically, it is provided by vibrators located inside the bus operator's seat cushion. Lane departure warning is provided in two stages. Stage 1 occurs when the vehicle-trajectory estimator determines that an un-signalized lane departure is likely. In Stage 1, the left or right side LED glows yellow, and the LCD icon appears. Stage 2 occurs if the bus continues on the trajectory toward the lane's edge without the turn signal being activated. In Stage 2, the LED light switches to red, the LCD icon continues to appear on the display, and the seat vibrates on the side to which the bus is drifting.

Figure I-5 Lane Departure Warning LEDs

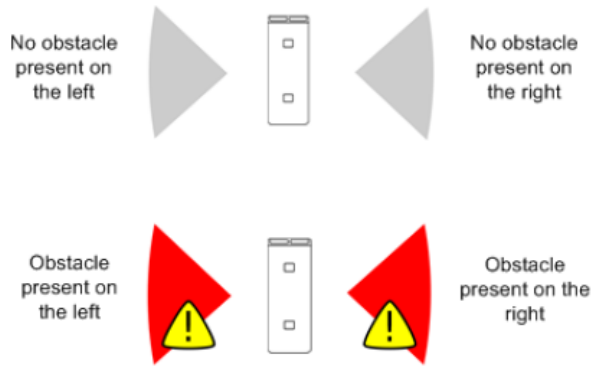
Side collision warning is provided to the bus operator via icons on the LCD touch screen. Examples of the warnings are shown in Figure I-7. If the turn signal is activated and an obstacle is detected to the side of the bus, the bus operator will see the side of bus icon on the LCD screen change from gray to red with a yellow triangle and exclamation point in the middle.

Figure I-7 Side Collision Icon on LCD Screen

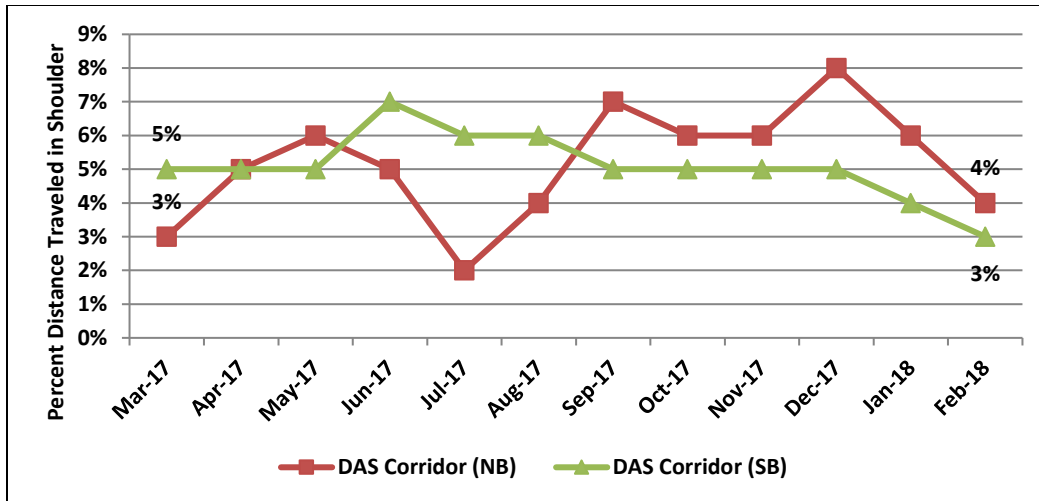
Because the DAS tracks bus lane position, it was possible to track the total distance the bus operators traveled in and out of the shoulder lane. It was hypothesized that the bus operators would use the shoulder more frequently over the course of the evaluation as they gained more confidence with the DAS; however, that did not occur, as shown in Figure 3-5. The percentages shown represent the percent distance traveled in the shoulder. This was calculated by dividing the distance in meters traveled in the shoulder by the total distance traveled. In the first month of the evaluation period, shoulder usage was 3% in AM NB direction; in the last month, it was 4%. Shoulder usage in the PM SB direction was 5% in the first month of the evaluation; in the last month, it was 3%. The one-year average was 5% for both AM NB and PM SB. Based on these findings, the DAS did not lead to an increase in shoulder usage.

Figure 3-5 Average Percent Distance Traveled in Shoulder by DAS Buses

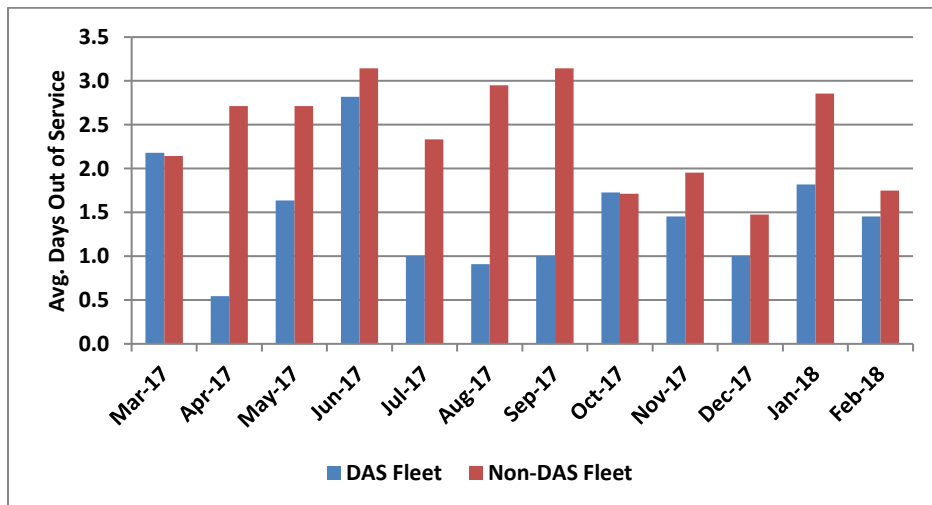
As expected and as shown in Figure 6-1, the DAS fleet had better maintenance performance than the non-DAS fleet. A bus from the DAS fleet was out of service 1.5 days per month, on average, compared to 2.4 days per month for a non-DAS bus.

Fleet	Average Days per Month Out of Service
DAS	1.5
Non-DAS	2.4
